Report No.E37218/FNBPAT
Date: August 20, 2026

REPORT OF TESTING

CLIENT	:	INDOMUDA SUKSES MANDIRI, PT.
ADDRESS	:	Villa Nusa Undah 2, Blok Y 10, No:8 , RT 06 / RW 024, Bojong Kulur, Gunung Putri, Bogor, Jawa Barat 16969 Indonesia
NAME OF SAMPLE	:	BOX PANEL
MERK	:	-
TYPE / MODEL	:	ID-DB-2604-DB-01
SPECIFICATION	:	H 2000 x W 800 x D 506 mm
TEST REQUIRED	:	IP42
TEST METHOD	:	SNI IEC 60529:2014 / IEC 60529:2001
RECEIVING DATE	:	August 12, 2026
TESTING DATE	:	August 18, 2026
RESULT	:	See Attached Sheet

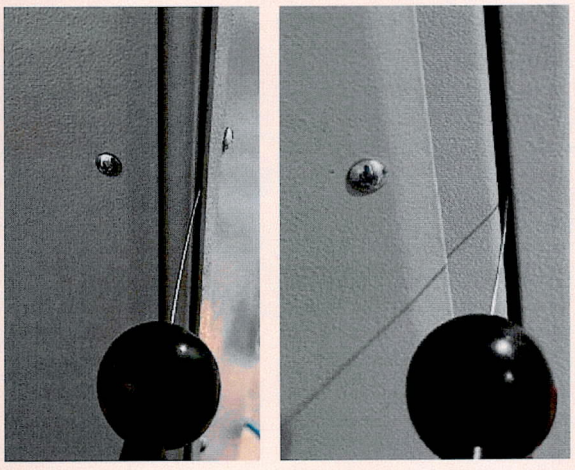
Picture of IP4X Testing

Index Protection Test Characteristic First Numeral 4			
Sample identification	**Description**	**Inspection**	**Result**
BOX PANEL	The Access Probe Ø 1,0 mm Shall Not Penetrate at all	The access probe is not penetrate at all	Pass

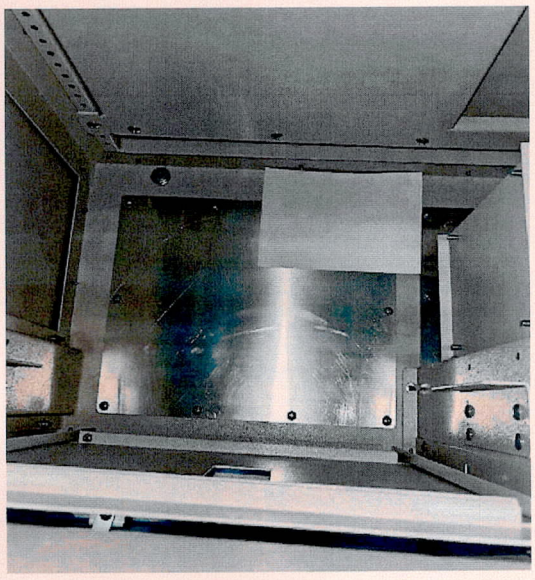
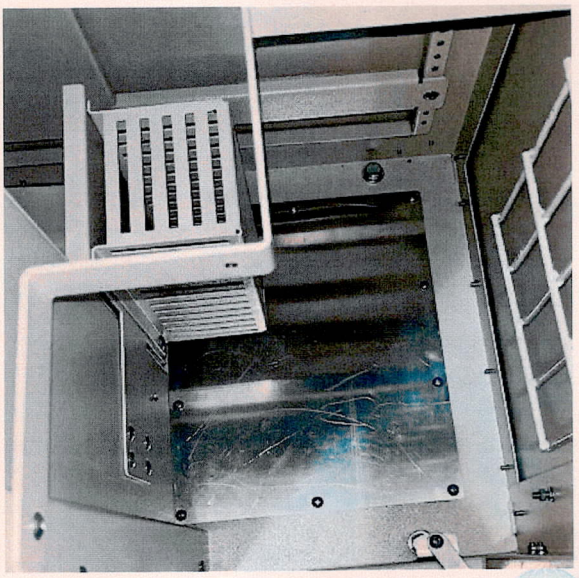
After Test

Index Protection Test Characteristic Second Numeral 2			
Sample identification	**Description**	**Inspection**	**Result**
BOX PANEL	Protected against direct spray of water up to 15^0 from vertical Vertically falling drops shall have no harmful effect when the enclosure is tilted at an angle of 15° on each vertical side	There is no trace of water in the panel	Pass
